MASSACHUSETTS COASTAL AREA
WESTON, MASSACHUSETTS

NORUMBEGA RESERVOIR DAM AND DIKES
NORUMBEGA RESERVOIR DAM AND EAST DIKE MA 00782
DIKE 2 AND DIKE 3 _____ MA 01208
DIKE 4 _____ MA 01209

**PHASE I INSPECTION REPORT
NATIONAL DAM INSPECTION PROGRAM**

MARCH 1980

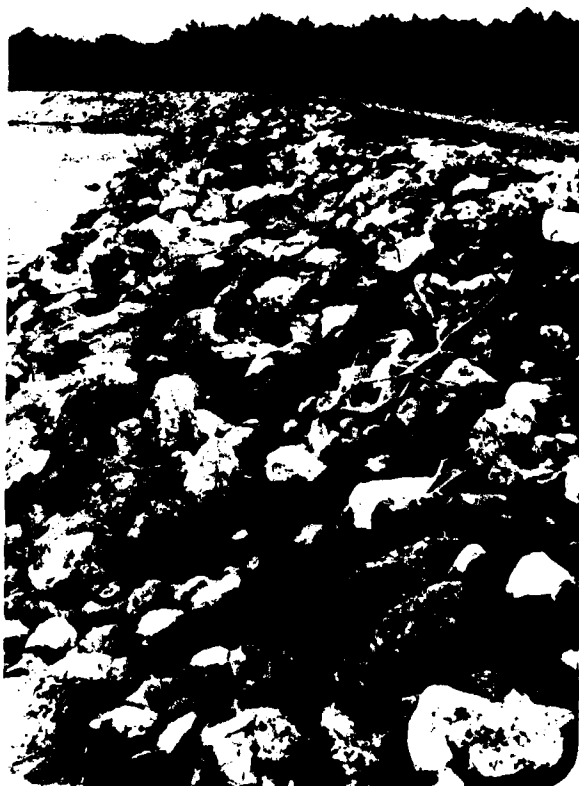
The main dam is zoned earth embankment about 1,100 feet in length and about 25 feet in height with an emergency spillway adjacent to the left abutment. The upstream slope of the main dam is protected by riprap which is in generally good condition, photographs 1 and 2. A small amount of brush and dead branches were observed on the upstream slope. An eroded area on the upstream slope to the right of the gatehouse is shown in photographs 9 and 10. This eroded area appears to have been caused by surface water runoff from the asphalt parking lot.

PHOTO NO. 2 - Upstream slope of
Dam as viewed from right
abutment area near gatehouse.

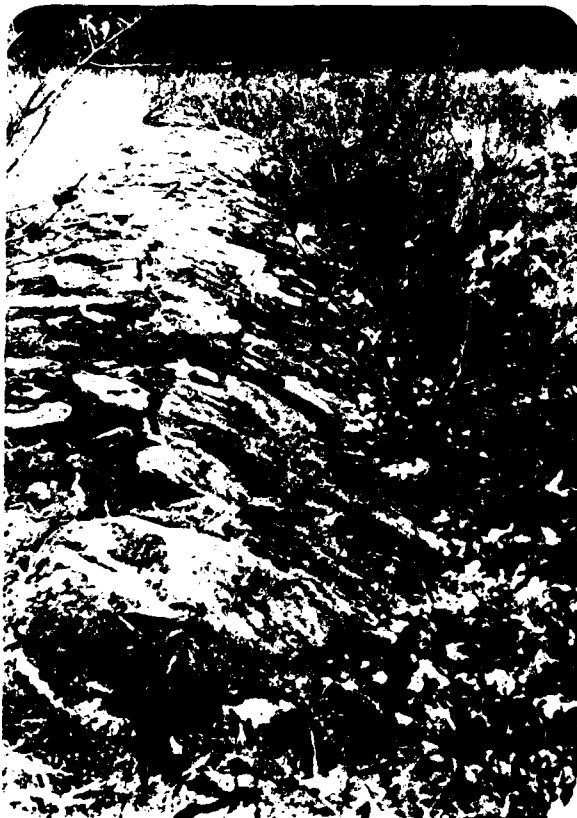
The spillway is located next to the left abutment of the main dam. The floor of the spillway is grass covered, photograph 5. The right side of the spillway channel is covered with mortared stone, as shown in photograph 6 and the spillway crest

PHOTO NO. 6 - Right spillway
wall as viewed from down-
stream end.

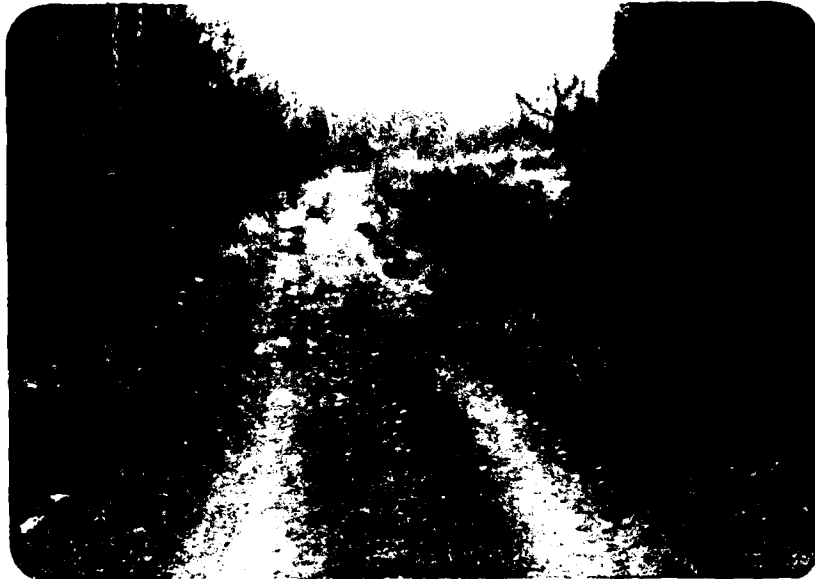
Dike 2 is zoned earth embankment about 310 feet long and about 15 feet in height and located over a pressure aqueduct designed to pass under the dike. The upstream slope is covered with riprap in good condition with the exception of tree growth near the top, photographs 19 and 20. The crest of the dike, shown in photograph 19, is used as a roadway and is covered with grass and a gravel surfacing. No evidence of cracking or misalignment of the crest that could be attributed to embankment movement was observed. The downstream slope is covered with grass, brush growth, and small trees, photograph 21. A drainage ditch was observed on the downstream left side of the dike. Water was observed in the ditch starting at the location of a 6 inch diameter clay pipe oriented roughly perpendicular to the crest of the dike, photographs 22 and 23. It is not known if the clay pipe is an outlet for a toe drain in the dike. The right abutment of the dike is a bedrock ridge.

PHOTO NO. 19 - Crest of Dike 2 as viewed from right abutment area.

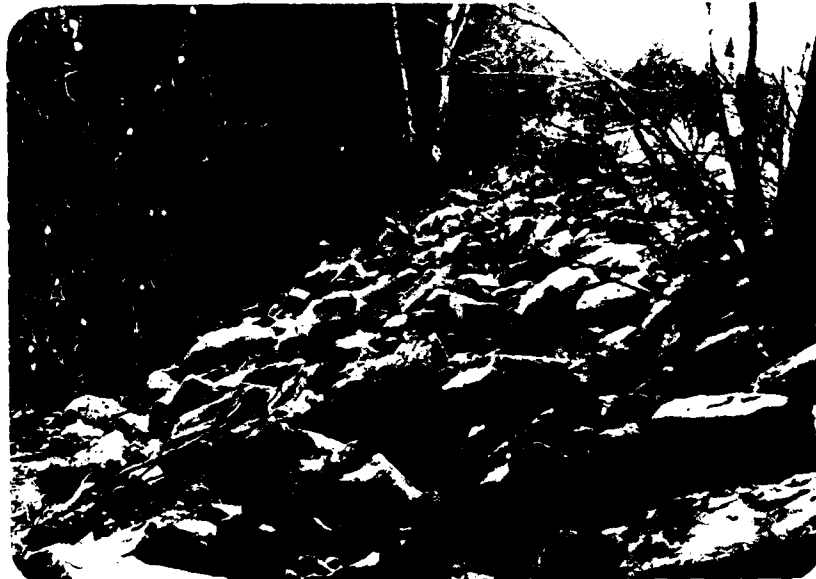
PHOTO NO. 20 - Upstream slope of Dike 2 as viewed from right abutment area.
